LONGINES®

CUSTOMER SERVICE

Concerne:	Technical Modification		
Customer service document N°:	TM_11_V1	Date jumper cal. L601.2	
Calibre:	L601.2	Marketing ref.:	L2.676.4.XX.X

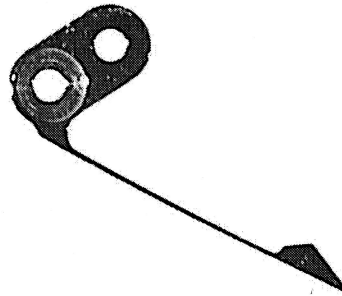
picture A

We have over time experienced that a few calibres L601.2 fail in the change of date.

This problem was caused by a too high tension of the unit-indicator-jumper CDNP ref. L29916494.

1. Reduce the tension of the unit-indicator-jumper CDNP ref. L29916494. (See picture A).
