LONGINES®

CUSTOMER SERVICE

Concerne:	Technical Modification		
Customer service document N°:	TM_11_V1	Date jumper cal. L601.2	
Calibre:	L601.2	Marketing ref.:	L2.676.4.XX.X

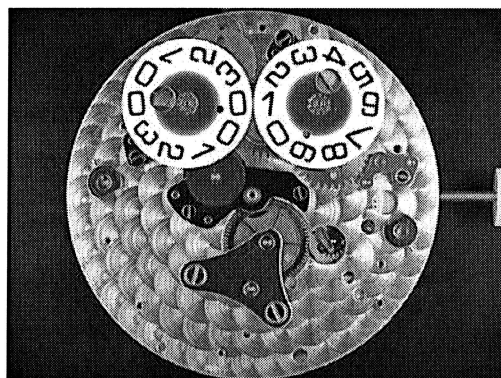
movement cal. L601.2

We have over time experienced that a few calibres L601.2 fail in the change of date.

This problem was caused by a too high tension of the unit-indicator-jumper CDNP ref. L29916494.

Please find herewith instructions on how to solve this problem.

The problem can be solved with the following adjustments:
